ENGINEERING CASE LIBRARY

Improving Odometer Reliability
at
Stewart-Warner Corporation (A)

Improving Odometer Reliability
at
Stewart-Warner Corporation (B)

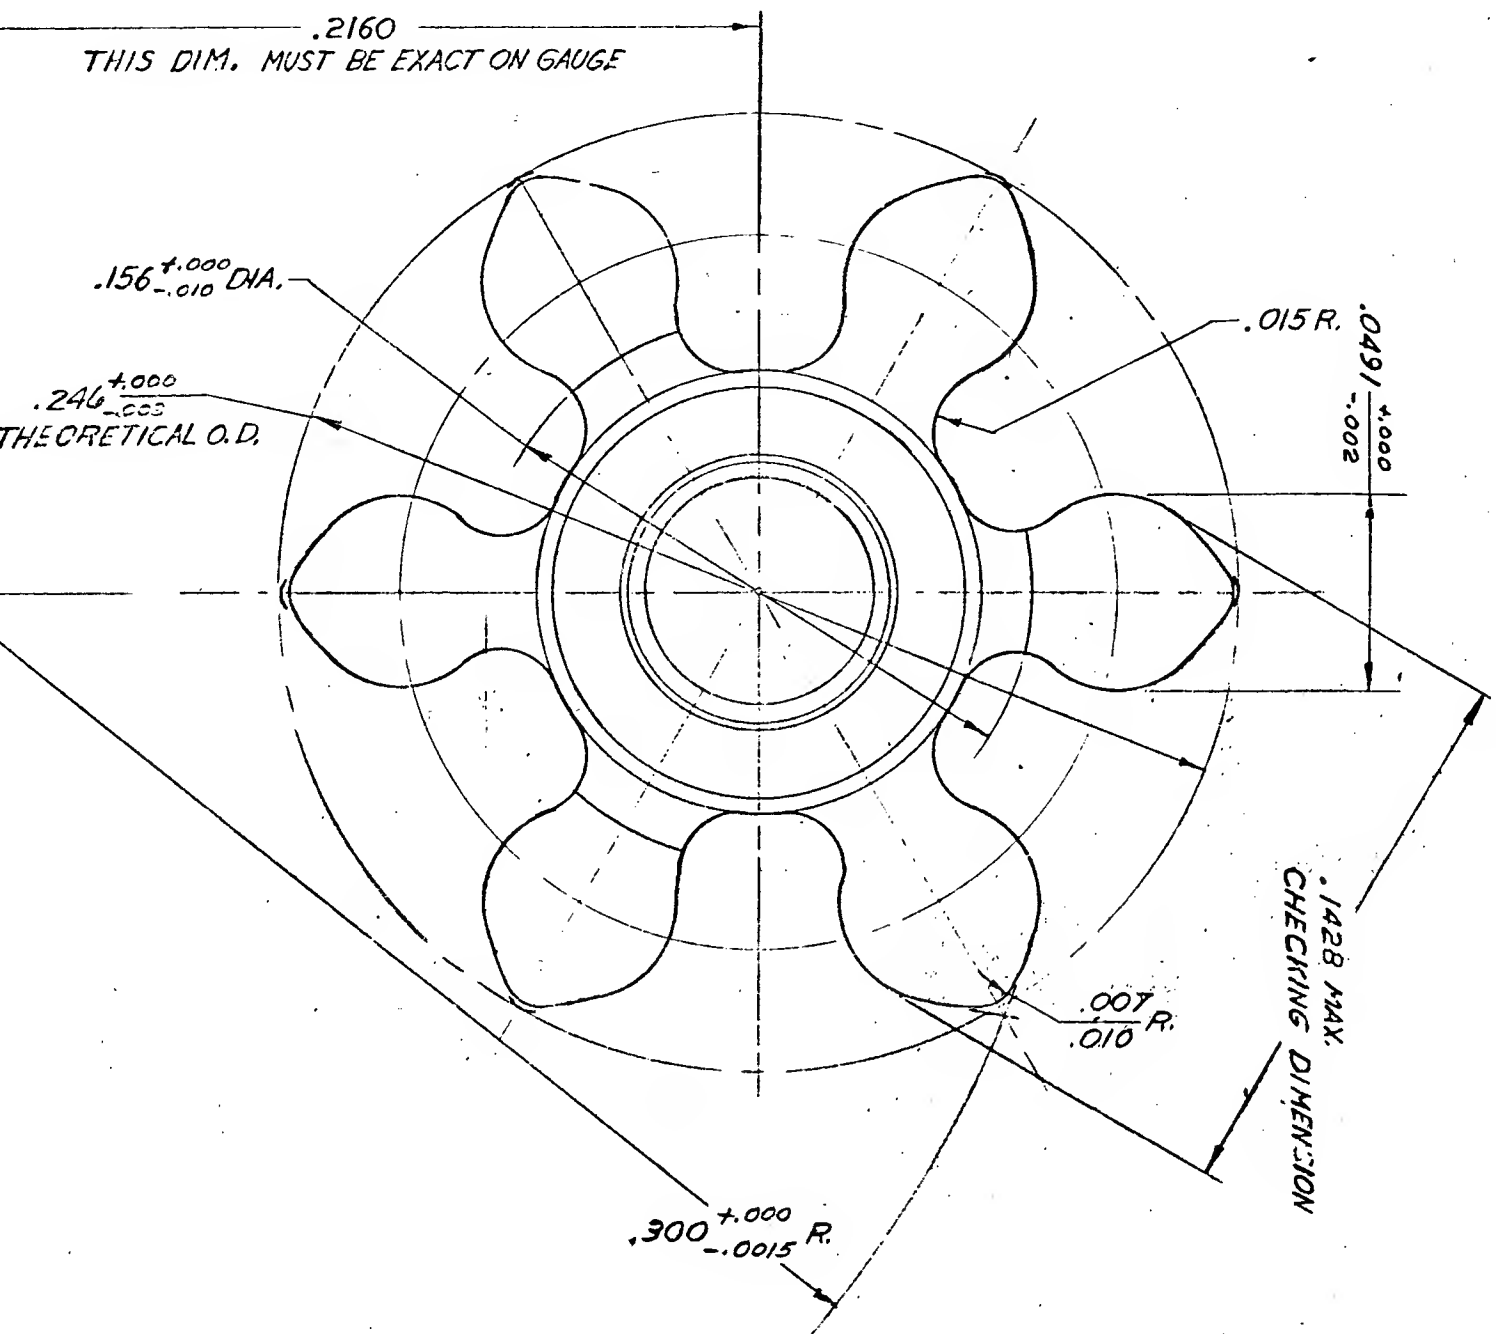
Exhibit A-10 PINION AND CARRIER ASSEMBLY

"From all field reports of odometer failures," Mr. Johnson said, "one thing was getting very clear. In practically every case the proper contact between the brass pinion and the adjacent dial wheel was lost. We had specified a 0.003 to 0.007 inch end play for the whole odometer assembly (Refer to Exhibit A-2), and to secure this

we were using arbor presses with calibrated dial gauges in the assembly line. However, we were still getting too many failures." Finally the major problem was traced to the inconsistency of the pinion and carrier assembly in the production. Dimensional variations in the final assembly were found to be the reason for many failures. These variations were occurring during the assembly of the brass pinion with the two side brackets while automatically projection welding them together. Too much pressure, when holding them together on the plates for welding, was changing the overall thickness of the pinion and carrier assembly. This was resulting in the wrong spacing of each component of the odometer, causing slips or binding wheel actions. During assembly on the automatic welding machine, plates holding the two pinion brackets would also shift slightly from time to time, resulting in misalignment of the pinion bearing holes. This would cause tightness and pinion motion binding in the final assembly. 100% inspection was becoming too costly for the company to do it continuously. The dial wheels were not causing any trouble. They were made by an injection molding process on automatic machines using polystyrene as wheel material. "Besides," said Mr. Johnson, "we had \$100,000 invested in molds for these machines. To change them would be too costly. In the final analysis we had decided that our failures were caused by burrs still present in the assembled pinions, and by the inconsistency of the projection welding operation joining the two pinion brackets."

all the parts were perfectly aligned during the welding assembly, plastic pinion bearings were easily sheared and partly damaged. This was producing excessive looseness of the pinion and hence causing it to lose contact with the internal teeth of the meshing dial wheels.

Mr. Powell knew then that he had to eliminate completely the welding operation. He decided to make a uniform, single piece part to replace the two brackets of the carrier unit. The functional requirements of the carrier were re-investigated and carefully scrutinized, and a new plastic pinion bracket and pinion were designed. Refer to Exhibit B-1 for the new pinion bracket, and Exhibit B-2 for the new plastic pinion, and Exhibit B-3 for pinion and bracket assembly. With this new design the vibration and the welding problems were completely solved, and the pinions were free of objectionable burrs. This design was immediately incorporated into the bicycle speedometer assembly. However, it soon became apparent that pinions could be dislocated from their proper positions by simply handling them during assembly operations. It was decided that this was undesirable for odometers that were sent to customers like Ford Motor Company for additional assembly into speedometers at their plant. This was attributed to the low rigidity and the excessive deflection of the short plastic shaft holding the pinion, and the poor locking characteristics of the new pinion in its seat.
